Thermal segregation of asphalt material in road repair

This paper presents results from a field study of asphaltic pavement patching operations performed by three different contractors working in a total of ten sites. It forms part of an ongoing research programme towards improving the performance of pothole repairs. Thermal imaging technology was used to record temperatures of the patching material throughout the entire exercise, from the stage of material collection, through transportation to repair site, patch forming, and compaction. Practical complications occurring during patch repairs were also identified. It was found that depending on the weather conditions, duration of the travel and poor insulation of the transported hot asphalt mix, its temperature can drop as high as 116.6 °C over the period that the reinstatement team travel to the site and prepare the patch. This impacting is on the durability and performance of the executed repairs. Cold spots on the asphalt mat and temperature differentials between the new hot-fill asphalt mix and existing pavement were also identified as poorly compacted areas that were prone to premature failure. For example, over the five-minut

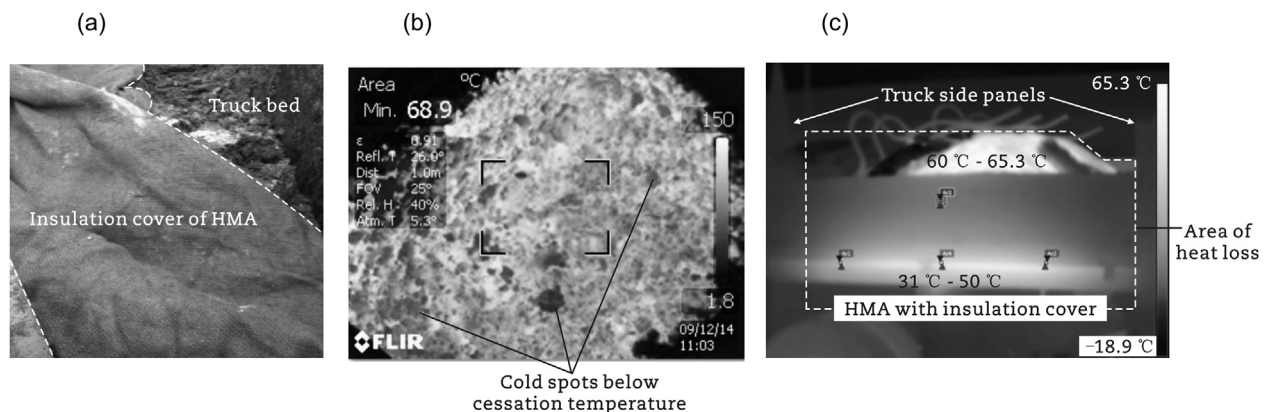
During transportation, the HMA was covered only with a thin insulation sheet (Fig. 2(a)). Two thermal images were taken immediately after the HMA was loaded onto the truck. At this point, thermal segregation had begun to develop, this shown as black areas on Fig. 2(b). The temperatures of the asphalt mat at this stage varied between 69 °C and 150 °C, indicating cold spots throughout the asphalt mat. Further, heat loss occurred through the panels of the truck and the cover sheet (Fig. 2(c)). The dark areas on the periphery of both thermal images are the surroundings to the HMA containment and not the material itself.

Fig. 2 – Asphalt collection at the production plant for repair sites 1–5. (a) Insulation cover of HMA. (b) Asphalt mat temperatures after collection. (c) Insulation cover temperatures.

production facility. Improper insulation of the hot-fill material and long travel time, in combination with low ambient temperatures, impacted on the asphalt mix temperature causing significant temperature losses through the panels of the truck and the cover sheet (Fig. 2). Table 2 and Fig. 3 present the overall transportation time and temperature drop versus time respectively of the asphalt from the production plant to each repair site.

There was an initial drop at temperature of 6.5 °C after 50 min of transportation between the asphalt plant and the first repair site. An overall drop of 60 °C occurred between the initial temperature of 150 °C and the delivery temperature on the last repair site, after 7 h and 25 min. A dramatic temperature difference of 33 °C occurred between repair sites 3 and 4 with the asphalt mat reaching 95 °C. This was a reduction of approximately 37% from the initial temperature of 150 °C. Asphalt temperature decreased by 40% between the asphalt plant and the last repair site.

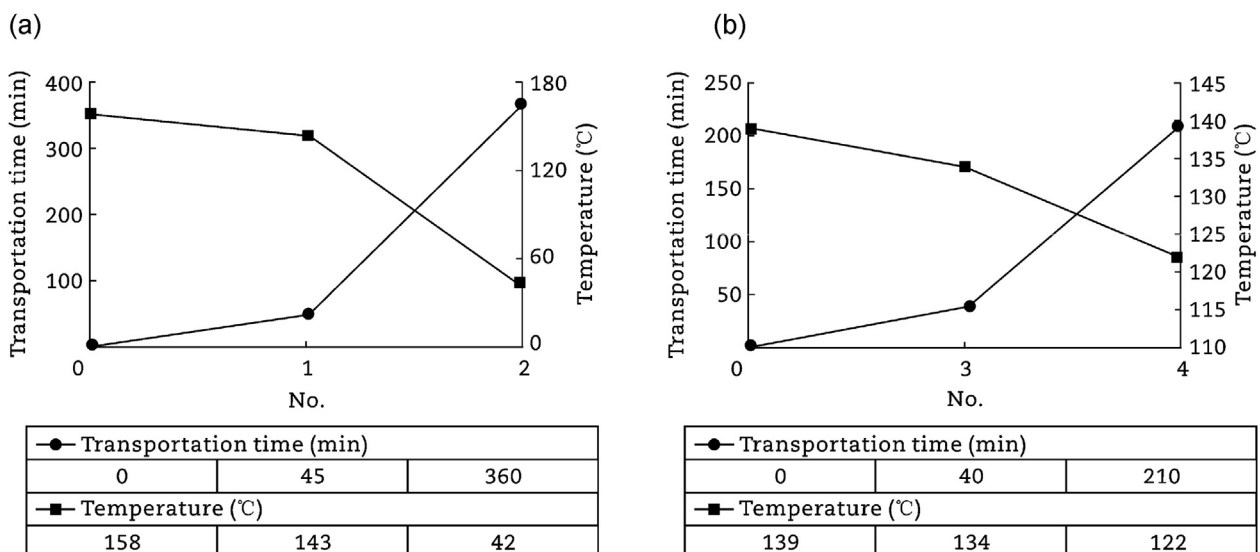
As the results show, during the transportation of the HMA at day 1 there was an overall dramatic decrease of asphalt mixture temperature of 116.6 °C. This heat loss is attributed to the travelling time and uncontrolled insulation of the hot material. At day 2, the overall maximum temperature drop was much less, reaching a difference between asphalt plant and last repair site of 16.5 °C.

**Fig. 7 – Temperature variation and transportation time of HMA between asphalt production facilities and each repair site. (a) Day 1 repair sites 7–8. (b) Day 2 repair sites 9–10.**

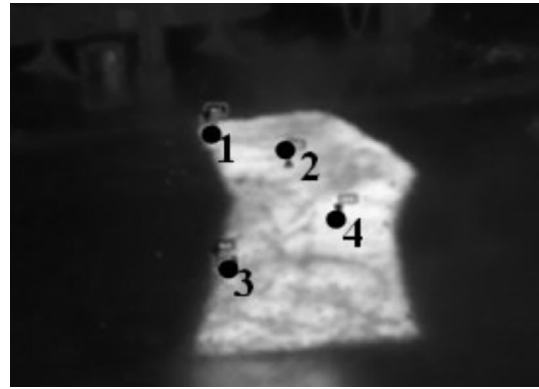
Fig. 10 represents temperature measurements at repair site 2. Four random points were selected to understand the variation in temperature. For each point, seven measurements were collected at different times. Points 1 and 3 were taken on the edges of the mat, and points 2 and 4 were in the middle area of the mat. The measurements

showed that different locations of the mat exhibit different repair quality. This means that the points with low temperature are expected to have been poorly compacted creating areas of future premature failure. The points located on the edges (points 1 and 3) had lower temperatures than those located in the middle of the mat (points 2 and 4). The temperature reduced, after 21 min reaching a temperature difference of 56.4 °C for point 1 from the first thermal image shot, 30.6 °C for point 2, 53.3 °C for point 3, and 32.9 °C for point 4 (Table 6). This means that the average percentage of temperature reduction on the edges was approximately 50% and it was approximately 29% in the middle. Consequently, the edges of the repair appear to have a temperature difference of approximately 28% from the middle of the mat, indicating low interface bonding between the host pavement and the hot-fill material which may lead to premature failure of the repair at its edges.

Fig. 10 – Thermal image of patch repair immediately after compaction on paving site 2.

The results indicate that, in a period of 5 min, the temperature for points 1, 2 and 3 dropped to approximately 33%, 65%, and 71%, respectively. The highest drop is for points 2 and 3 which are located at the edges of the repair. Similar results were observed for the repair examples of Contractor A,

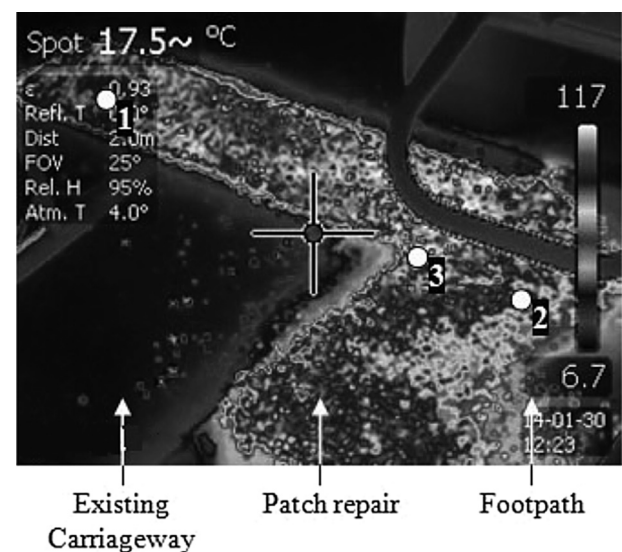
image gives an indication of the overall temperature variation of the mix immediately after compaction. Three points (Points 1, 2 and 3) were studied in more detail. Point 1 was situated away from the kerb line and drainage area. Point 2 was located near the kerb line and within the drainage area and, finally, Point 3 was located at the edge between the new and old reinstatement. Further, due to the position of the repair water was flowing through the patch constantly. Eight temperature recordings were collected for each point all these displayed in Table 7. All points had an initial temperature of approximately 100 °C. This is a 42 °C drop from the initial temperature of 142 °C when the HMA was loaded onto the truck.

Fig. 11 – Thermal image of patch repair immediately after compaction on repair site 6.

indicating a similar weak point of the executed repairs. Usually, the areas of the repair with a temperature less than the cessation temperature tend to have lower density and cause failure of the patch repair.
